PACSystems* RX3i

IC695ETM001-FS

GFK-2332R

Ethernet Interface Module

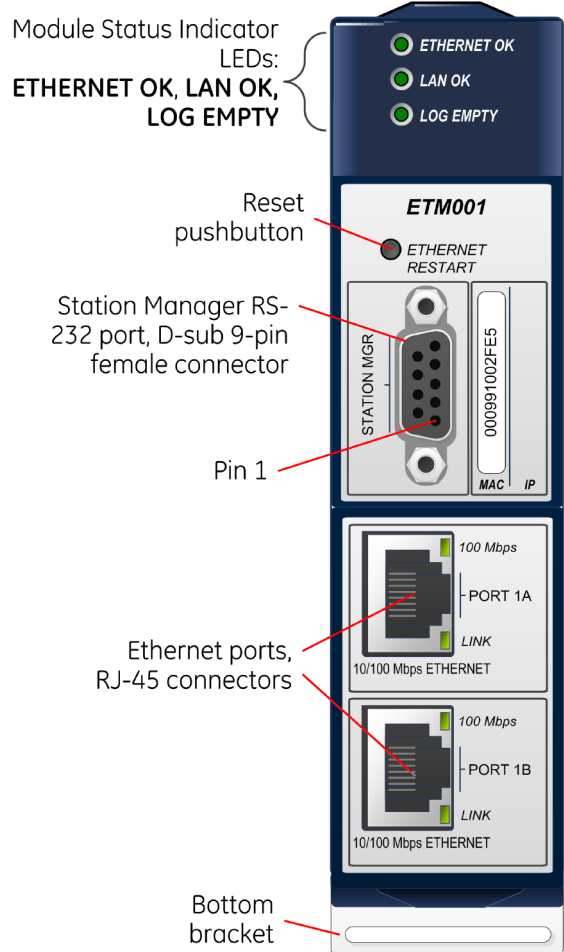
- Two auto-sensing 10Base T / 100Base TX RJ-45 shielded twisted-pair Ethernet ports for direct connection to either a 10BaseT or 100BaseTX IEEE 802.3 network without an external transceiver. There is only one interface to the network (only one Ethernet MAC address and only one IP address).

- LEDs: Ethernet OK, LAN OK, Log Empty, individual port activity and speed LEDs.
- Configurable stand-alone Redundant IP addressing, which allows a single IP address to be assigned to corresponding Ethernet modules in two different controllers. The Redundant IP address is configured in addition to the normal unique IP address of each Ethernet module. Under application logic control, only the Ethernet module in the active unit can use the Redundant IP address.
